BRICOLA CATCHMENT: REPAIR OF LA MAYA CHANNEL

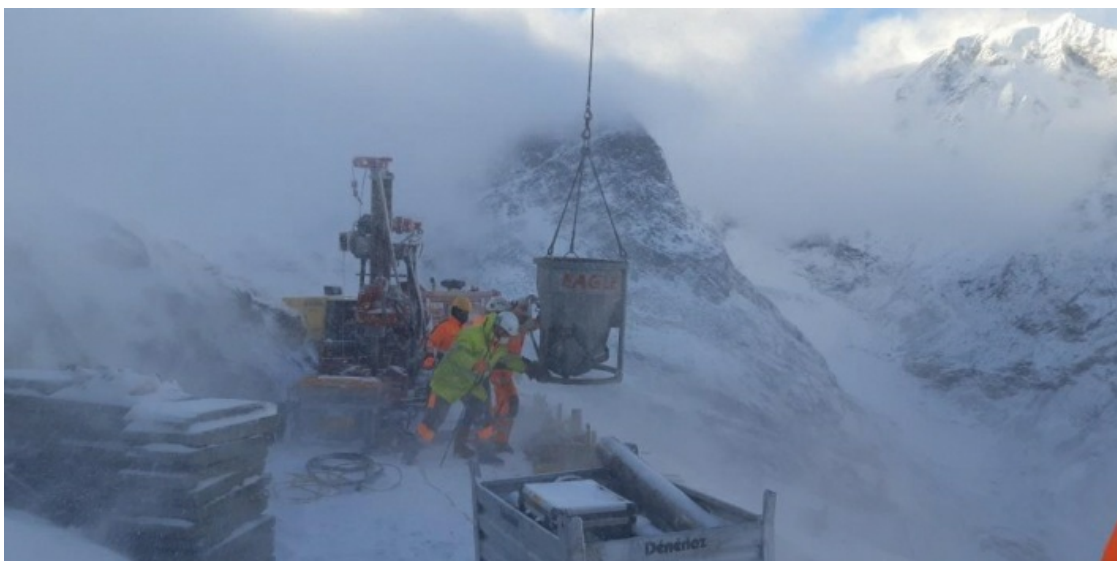
During the storm, there was a landslide some ten metres long beneath the

channel, which did not cause a break in the HDPE DN250 pipe held within it but inevitably meant that the works would be at risk when the snow next melted in Spring 2021. Grande Dixence SA carried out urgent works before winter with the help of HYDRO Exploitation's Civil Engineering Unit. The scope of their work was:

- Assessment of the damage and development of the design for making safe.
- Direction of the works, award of contract, technical and financial monitoring.
- Delivery of a crawler drill to the site, at an altitude of 2,500 metres, in November, using a Super Puma helicopter.
- Construction of seven micropiles placed at 1.20 metre intervals, composed of SwissGewi rods, 40 mm in diameter, with a total length of 9.00 m, sealed in 3.00 m of solid rock and 3.50 m of moraine.
- Reconstruction of the channel and its underpinning in black concrete to minimise the visual impact on the right flank of the Ferpècle valley.
